# Wind-Induced Dynamic Loading and PV Module Frame Fatigue Crack Initiation and Propagation

By: Frank Oudheusden & Chris Needham (Azimuth Advisory Services), Jon Ness, Kyle Johnson & Charles Milton (Matrix Engineering Consultants)

## Grenadines Project Information

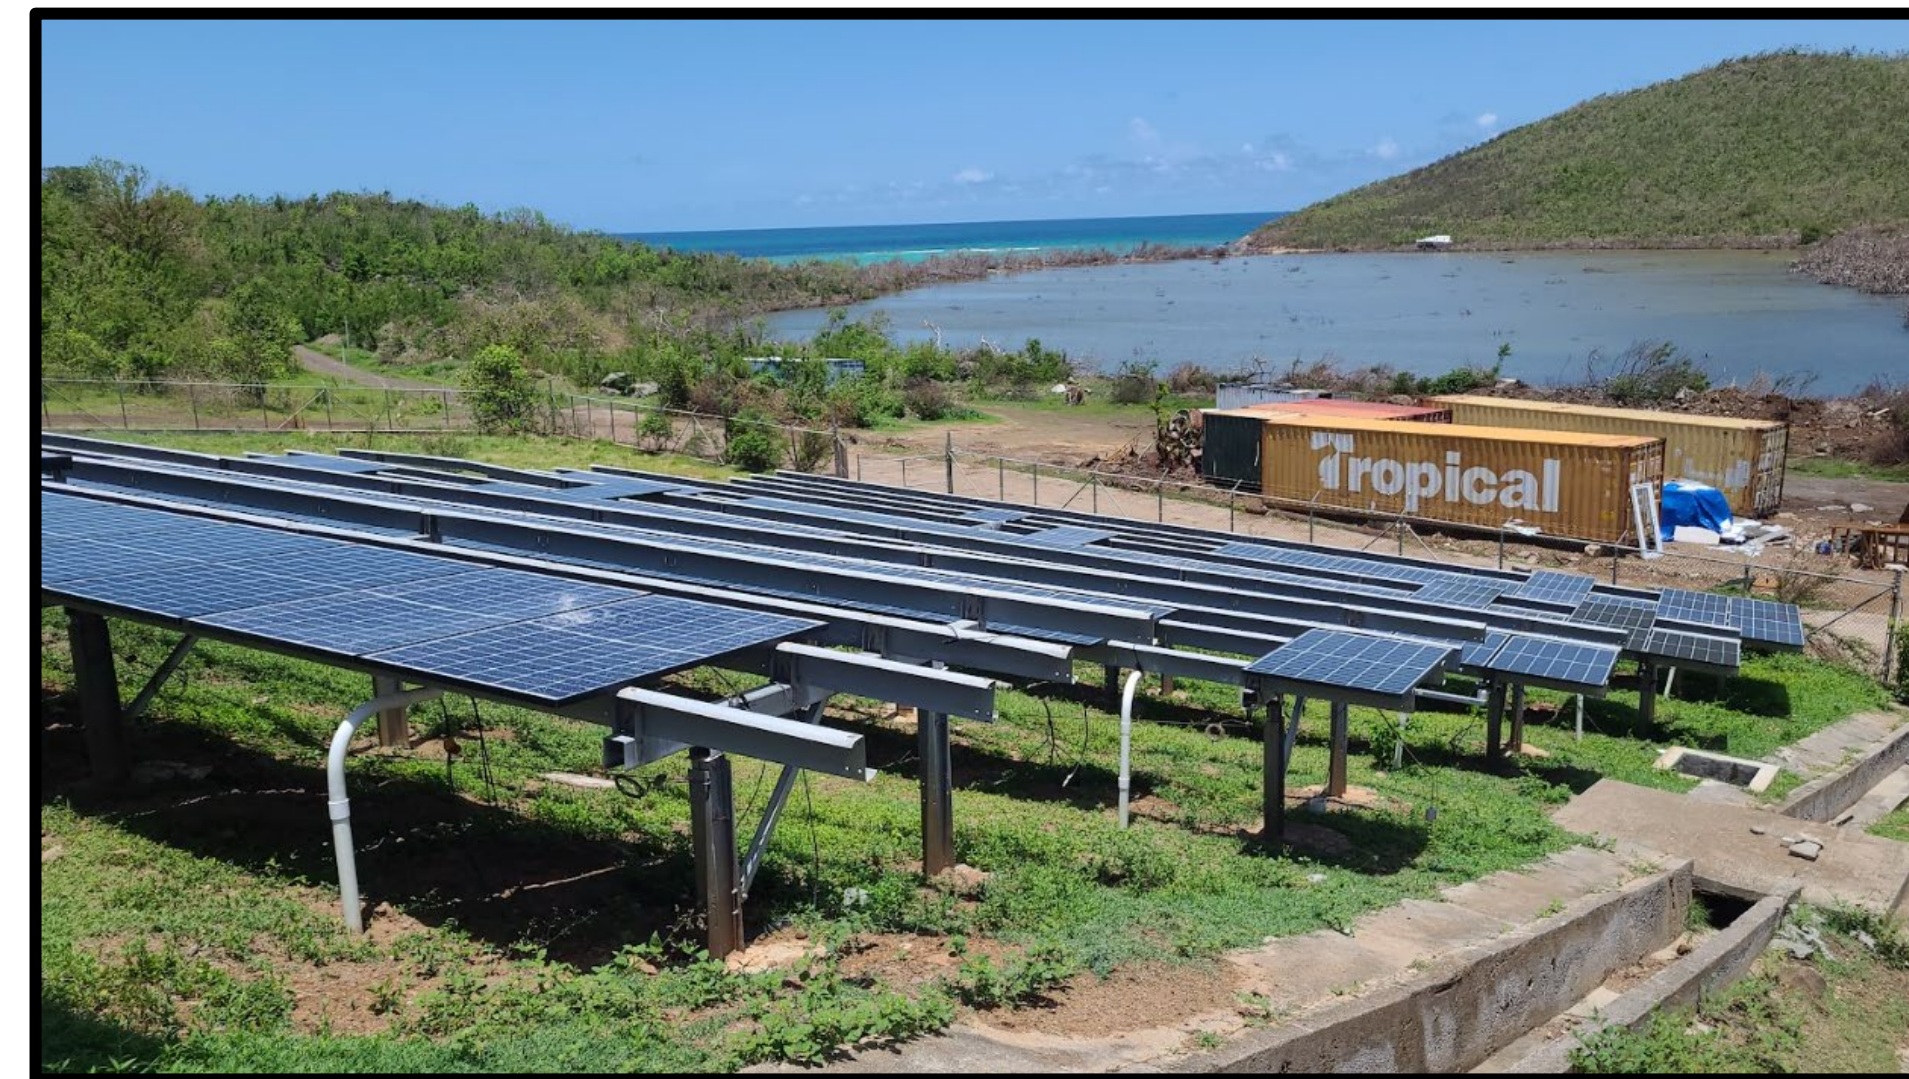
- The project site was modeled after Solar Under Storm 1 recommendations and by all accounts performed admirably. To have a test bed for resiliency improvements hit by a second hurricane is incredibly improbable and an amazing opportunity to find new failure modes.
- Racking utilized dual-post foundations and low-angle module mounting, resulting in zero primary failure modes in the racking system.
- 31% of modules remained visibly undamaged.
- No witnessed hardware loosening due to use of Nylock nuts (vibration resistant hardware)
- Mild structural corrosion was present - typical of the region and age.
- Module frame tear-out was the primary cause of module liberation. Photo below >95% of all module hardware

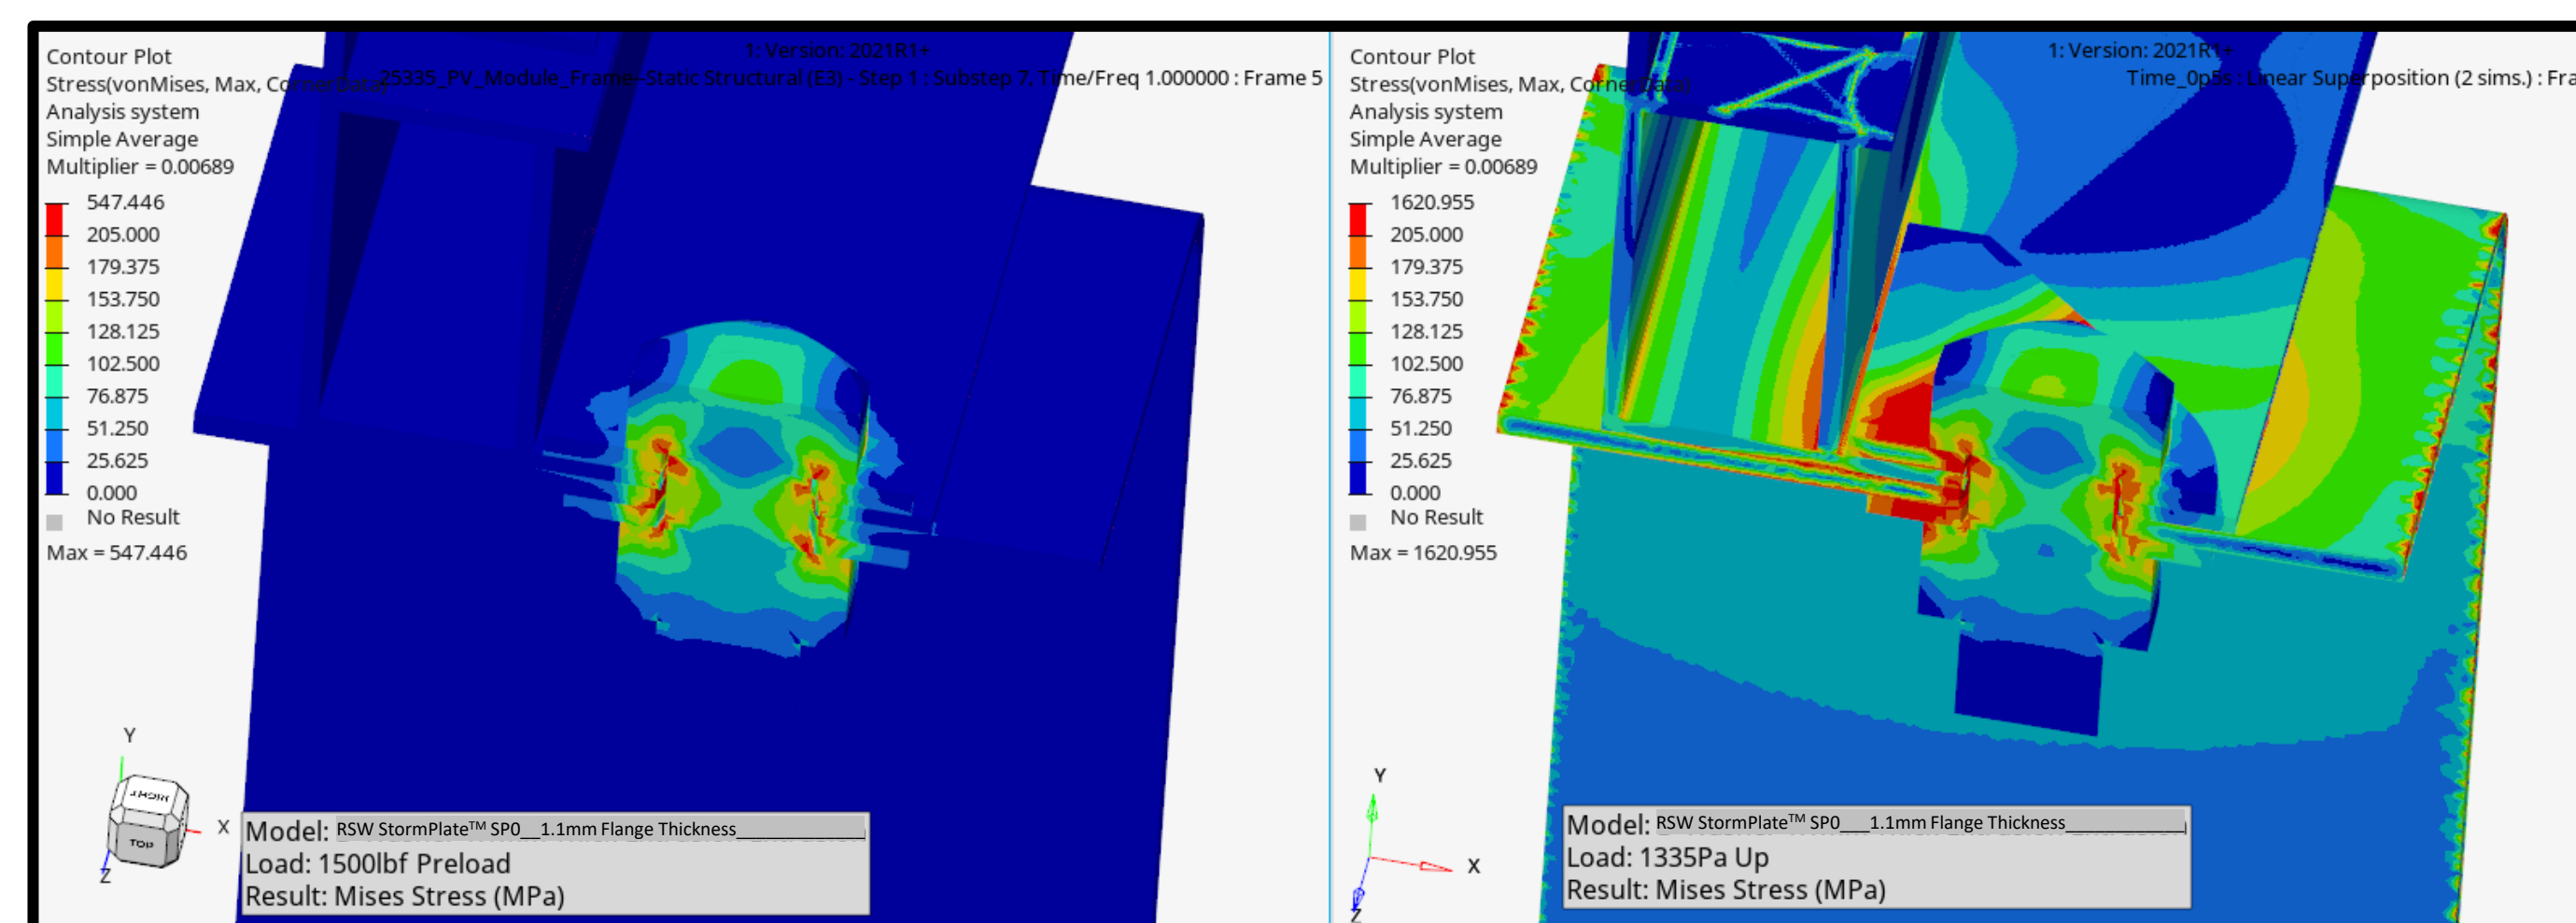
RSW StormPlate™ SP0 design was tested to distribute the load. FEA Static results showed a 33% reduction in peak stress in the AL frame, drastically improving the frame performance and should (with further IEC61215 testing) improve overall module performance if the primary failure mode was frame buckling (which it often is)

The addition of the RSW StormPlate™ SP0 in the analysis shows a great area of promise.

RSW StormPlate™ SP0 showed a 450x increase in the number of cyclical loads compared to the 1.1mm thick frame utilizing industry-standard hardware stacks.

As modules evolve to become larger and have less rigidity, fastener selection needs to be tailored to the application. RSW StormPlate™ SP0 is one example of how to better support these smaller frames against stress concentrations. Application specific mounting innovation and techniques like load distribution are key to reducing module liberations in the field.

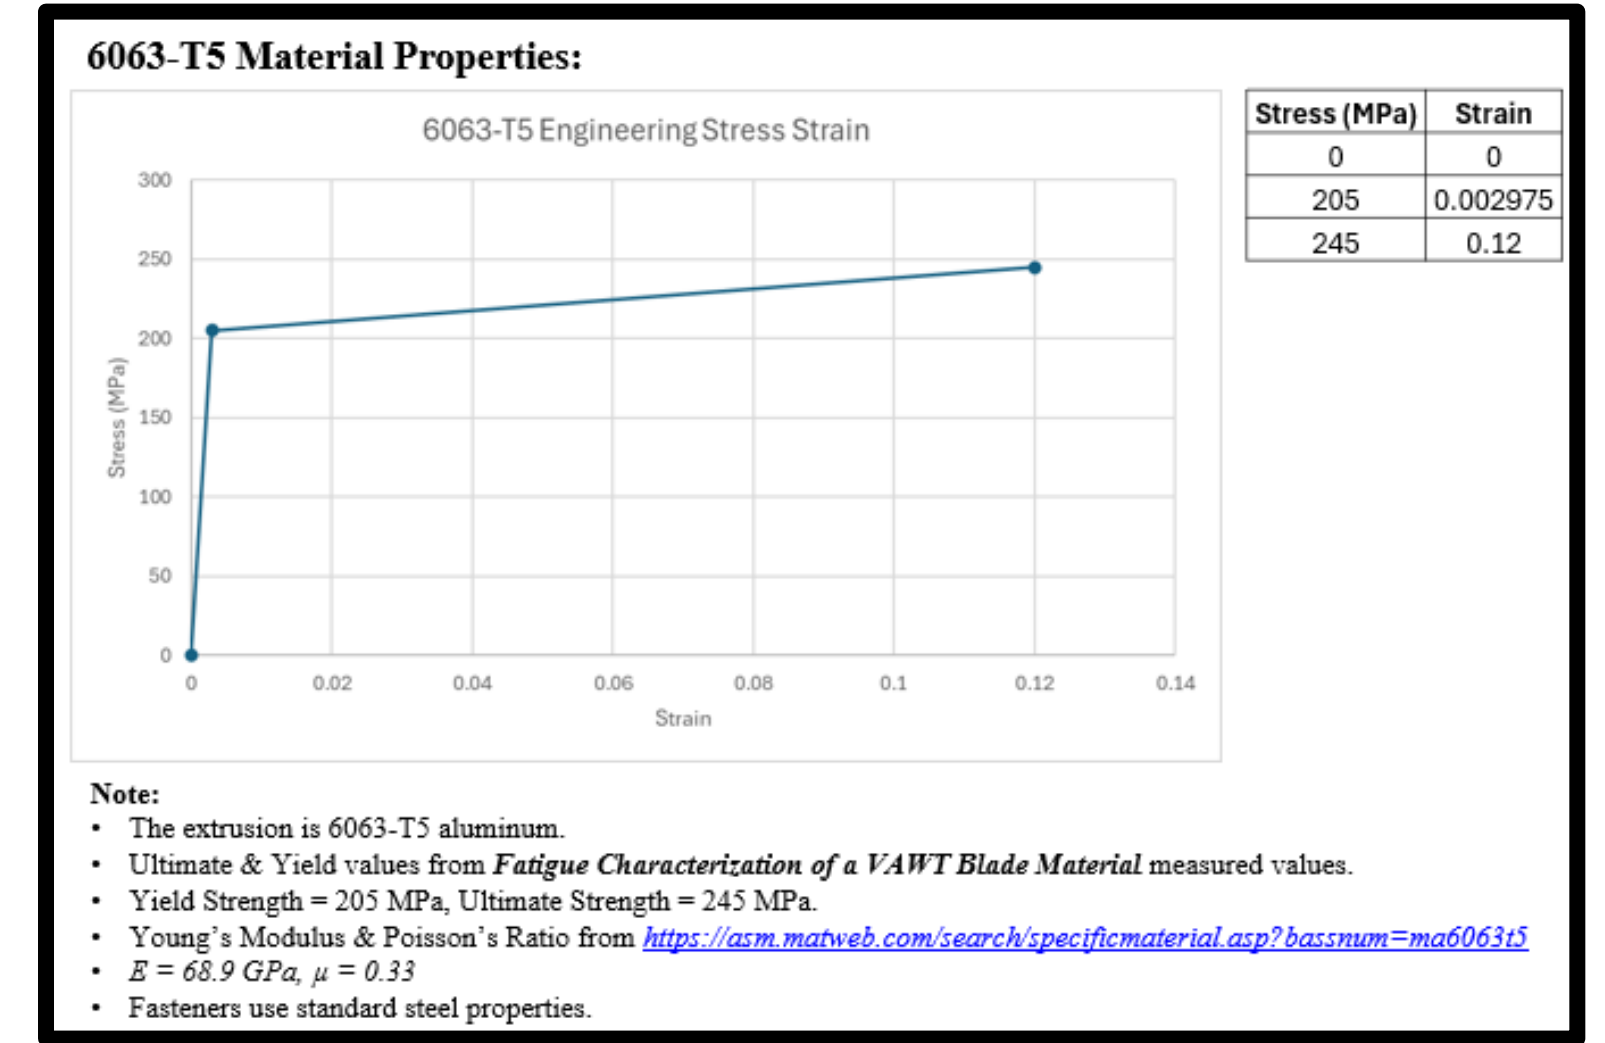
## FEA Model Setup

- Material properties (6063-T5) and an appropriate S/N fatigue curve for the were selected.
- These properties combined enable non-linear FEA analysis of the fastener, washer selection and frame performance.
- As the frame deforms under load, stresses and forces change. It is important to capture these changes as the static FEA analysis showcased that the vast majority of IEC61215 testing would yield a module frame with permanent plastic deformation, even under 40-60% of the rated static load.
- This in-turn begets the question of “what determines a pass / fail for module performance in IEC 61215?”. Electrical continuity considerations are primary in this regard.
